# STORMWATER OUTFALL PIPE STREAM SCOUR INSPECTION

# TOWNSHIP OF ROCHELLE PARK

PROJECT NAME: Stormwater Outfall Survey PROJECT No.: ROP-153

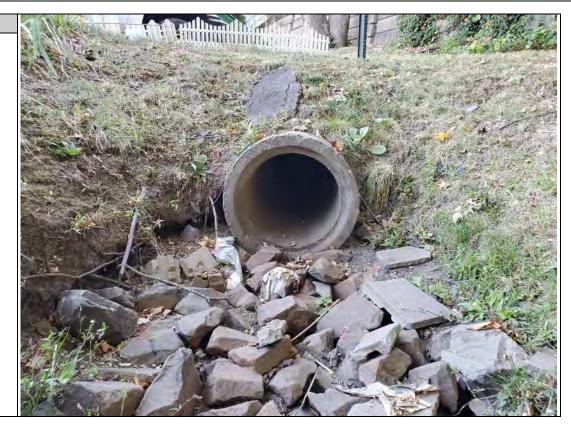
# Photo No. 2.

Discharge ID: D-2

150 West Passaic St

24" RCP

Good

No

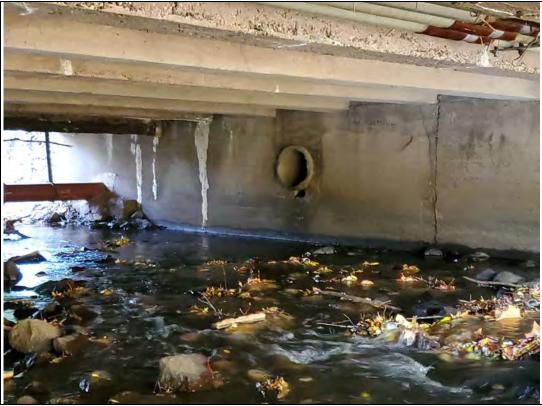
# Photo No. 3.

Discharge ID: D-3

120 West Passaic St

24" RCP

Good

No

No

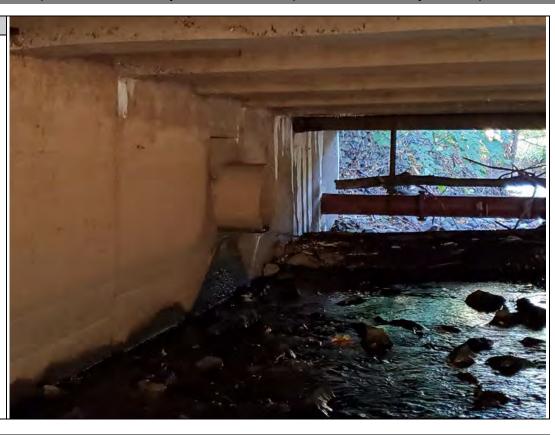
# Photo No. 4.

D-4

151 West Passaic St

15" RCP

Poor

Yes

Repair Headwall and Install Conduit Outlet Protection

**NJDEP Permit Required**

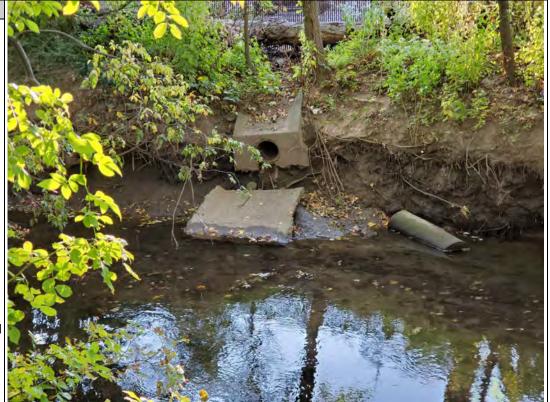
# Photo No. 5.

Discharge ID: D-5

32 Schlosser Dr (Approx.)

18" HDPE

Good

No

Install Headwall and Conduit Outlet Protection NJDEP Permit Required

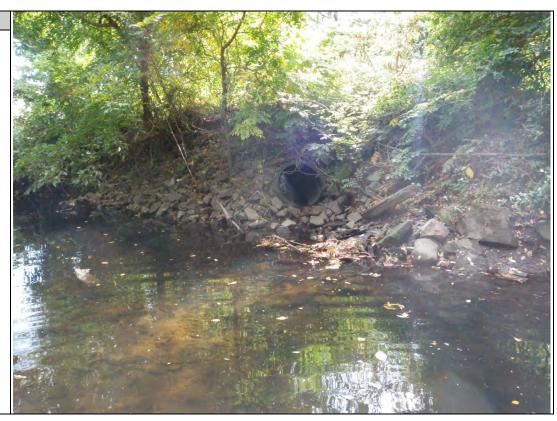
### Photo No. 6.

D-6

161 West Passaic St

18" RCP

Excellent

Νo

No

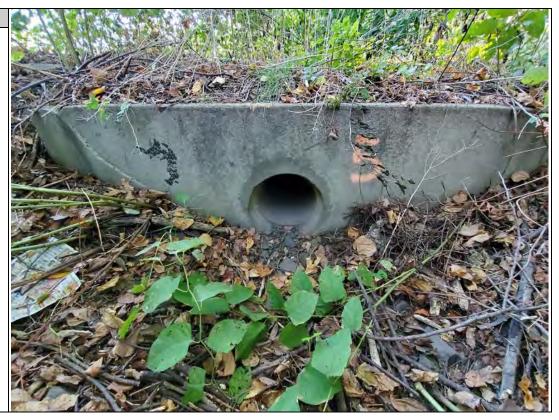
# Photo No. 7.

Discharge ID: D-7

201 West Passaic St

18" Elliptical RCP

Poor

Yes

Repair: Install Conduit Outlet Protection

**NJDEP Permit Required**

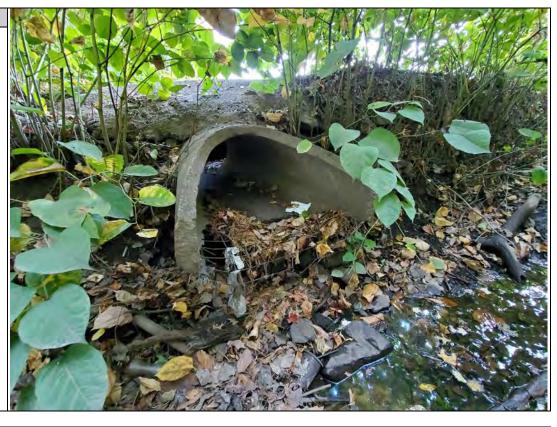
### Photo No. 8.

D-8

235 West Passaic St

18" RCP

Good

Yes

Install Headwall and Conduit Outlet Protection

NJDEP Permit Required

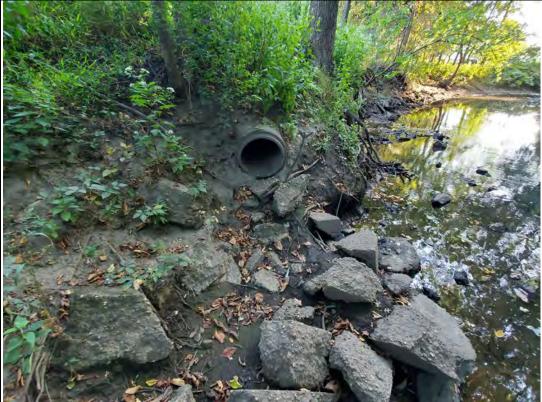
# Photo No. 9.

Discharge ID: D-9

21 Hobart Ct

15" RCP

Excellent

No

No

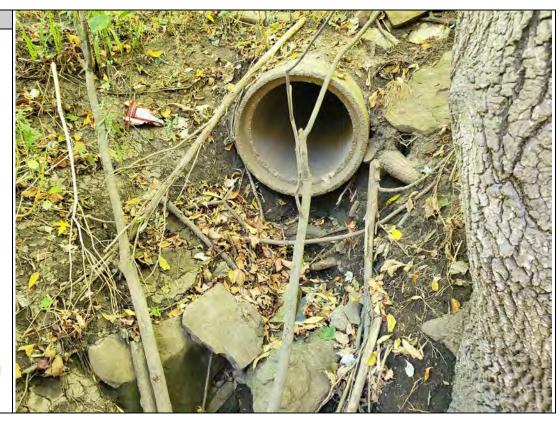
# Photo No. 12.

D-12

171 Chestnut St

18" RCP

Good

Yes

Install Conduit Outlet Protection

**NJDEP Permit Required**

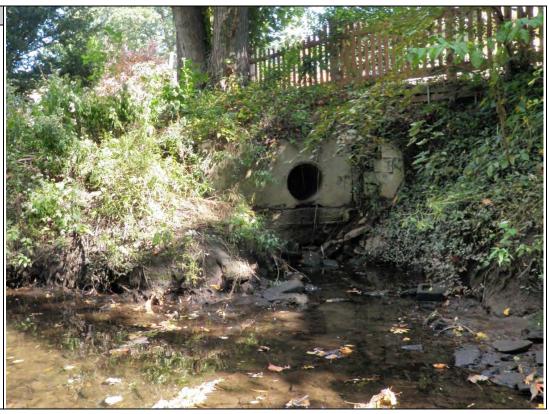
# Photo No. 13.

Discharge ID: D-13

158 Forest Pl

15" RCP

Fair

No

Install Headwall and Conduit Outlet Protection NJDEP Permit Required

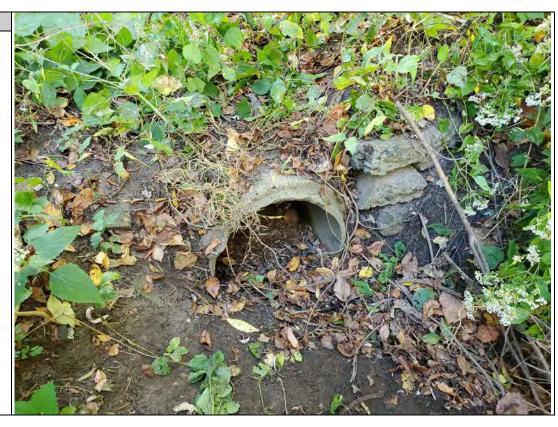
# Photo No. 14.

Discharge ID: D-14

145 Forest Pl

18" RCP

Fair

Yes

Investigate

Install Conduit Outlet Protection

NJDEP Permit Required

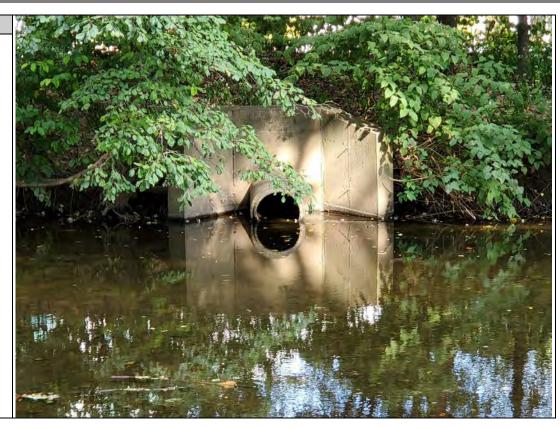
# Photo No. 16.

D-16

<u>Location:</u> Saddle River County Park

24" CMP

Fair

Yes

Install Headwall and Conduit Outlet Protection

### **NJDEP Permit Required**

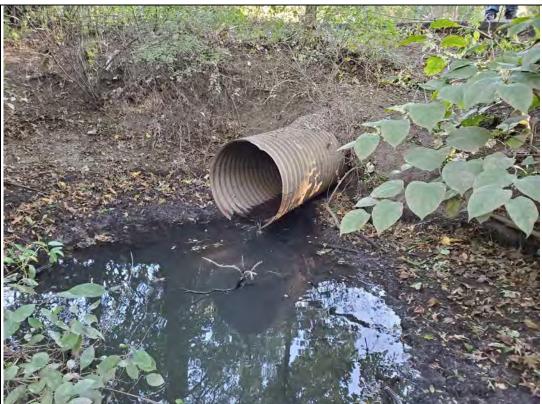
# Photo No. 17.

Discharge ID: D-17

23 Brooks Ave

Unknown

Locate Pipe and Reevaluate

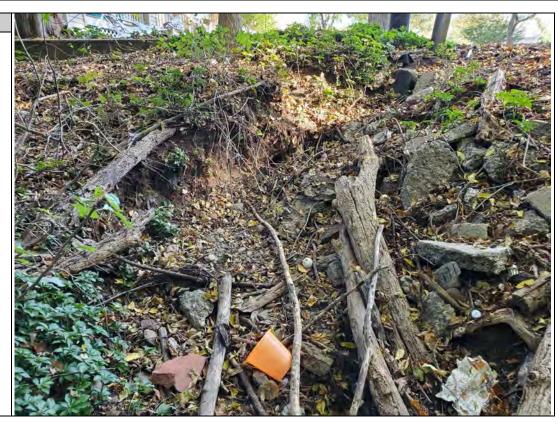
# Photo No. 18.

D-18

151 West Passaic St

42" RCP

Excellent

No

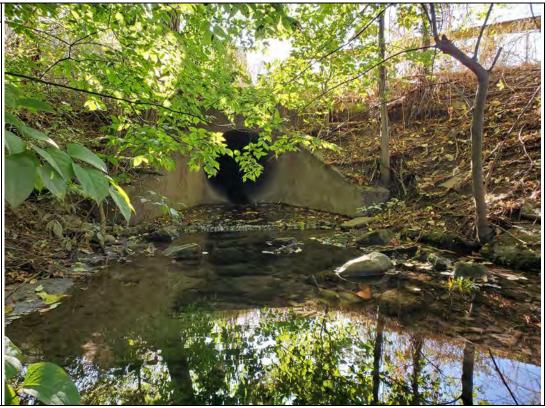
# Photo No. 19.

Discharge ID: D-19

Railroad Ave

18" RCP

Good

No

No

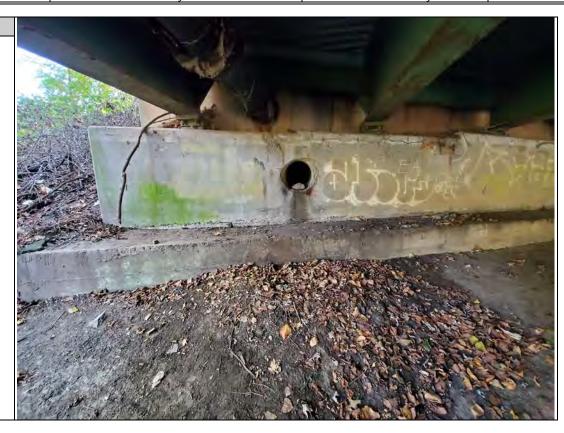
# Photo No. 20.

D-20

Railroad Ave

15" RCP

Good

Install Flared End Section NJDEP Permit Required

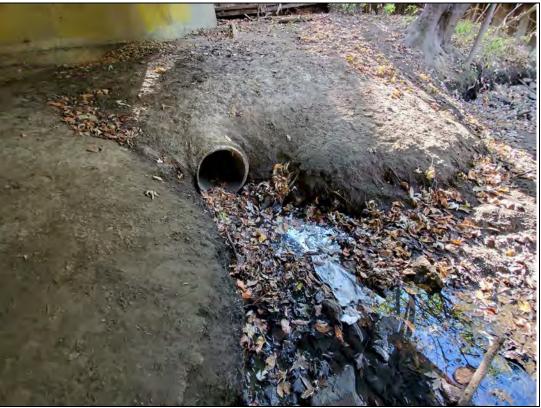
# Photo No. 21.

Discharge ID: D-21

22 Becker Ave

15" RCP

Good

Scour: No

No

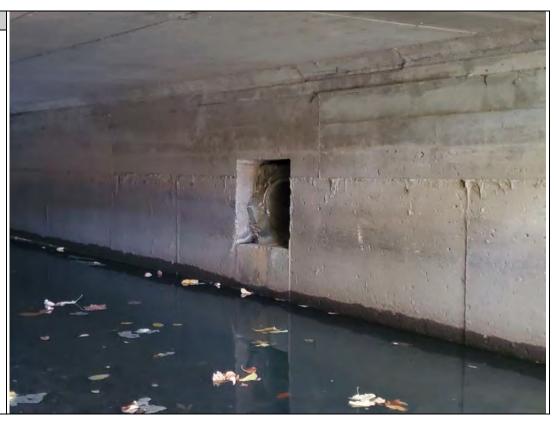
# Photo No. 22.

D-22

Becker Ave

15" RCP

Good

No

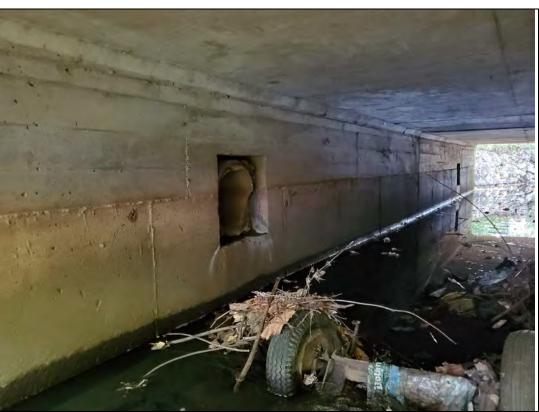
# Photo No. 23.

Discharge ID: D-23

Becker Ave

<u>Size:</u> 42" RCP

Good

No

No

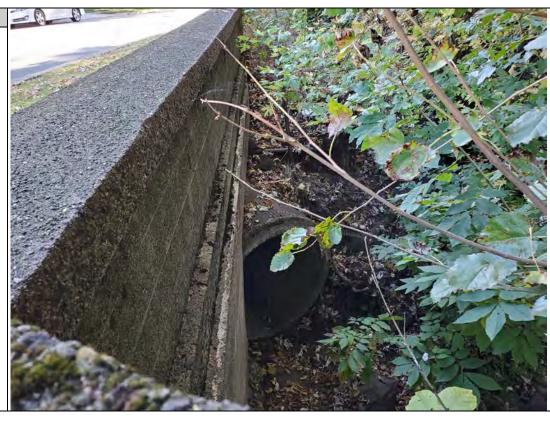
# Photo No. 24.

Discharge ID: D-24

<u>Location:</u> 91 Rochelle Ave

4'x3' Box Culvert

Excellent

No

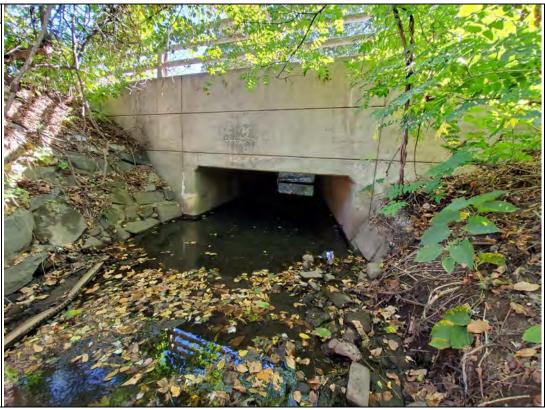
# Photo No. 25.

Discharge ID: D-25

12 Rochelle Ave

12" RCP

Good

No

No
